East Shepherd Canyon Emergency Project Revegetation Plan

Revegetation Plan

EAST SHEPHERD CANYON WATER MAIN BREAK REPAIR PROJECT

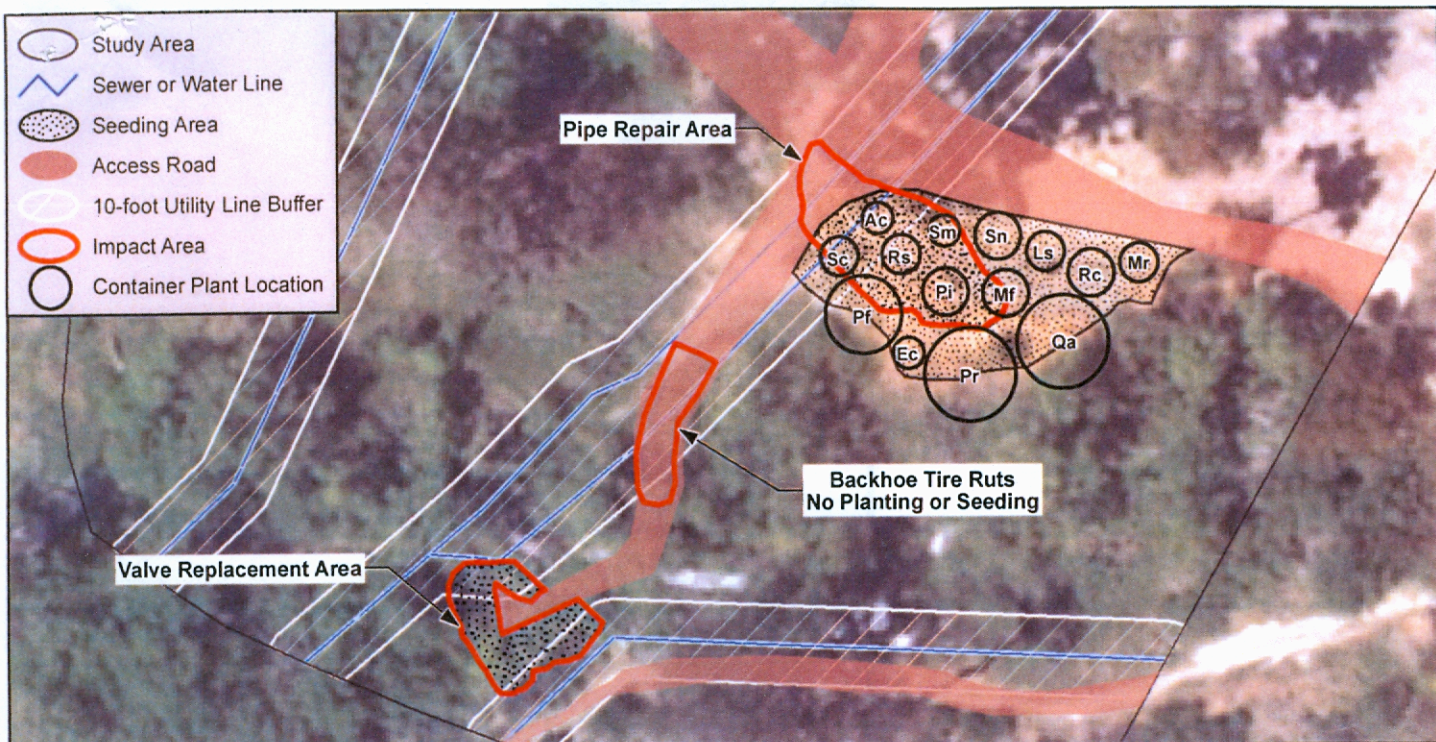
Container Plants (Pipe Repair Area)		Center (feet)	Quantity required
California sagebrush (Ac)	<i>Artemisia californica</i>	4	1
California fuchsia (Ec)	<i>Epilobium canum</i>	4	1
Southern honeysuckle (Ls)	<i>Lonicera subspicata</i>	5	1
Chaparral bush mallow (Mf)	<i>Malacothamnus fasciculatus</i>	6	1
California deergrass (Mr)	<i>Muhlenbergia rigens</i>	5	1
Western Sycamore (Pr)	<i>Platanus racemosa</i>	12	1
Fremont cottonwood (Pf)	<i>Populus fremontii</i>	10	1
Holly-leaf cherry (Pi)	<i>Prunus ilicifolia</i>	6	1
Coast live oak (Qa)	<i>Quercus agrifolia</i>	12	1
Fuchsia-flowered gooseberry (Rs)	<i>Ribes speciosum</i>	5	1
California rose (Rc)	<i>Rosa californica</i>	6	1
Cleveland sage (Sc)	<i>Salvia clevelandii</i>	5	1
Black sage (Sm)	<i>Salvia mellifera</i>	4	1
Mexican elderberry (Sn)	<i>Sambuchus nigra ssp cerulea</i>	6	1
		Total:	14
Seed Mixture (Pipe Repair and Valve Replacement Areas)		% purity/ germination	lbs/acre

Western ragweed	<i>Ambrosia psilostachya</i>	20/30	3
California sagebrush	<i>Artemisia californica</i>	15/60	2
Douglas mugwort	<i>Artemisia douglasiana</i>	15/50	2
Mule fat	<i>Baccharis salicifolia</i>	10/20	2
California sand aster	<i>Corethrogyne fillaginifolia</i>	15/30	1
California fuchsia	<i>Epilobium canum</i>	60/40	1
Fringed willow herb	<i>Epilobium ciliatum</i>	70/60	3
Salt heliotrope	<i>Heliotropium curassavicum</i>	20/60	1
Goldenbush	<i>Isocoma menziesii</i>	40/30	1
Salt marsh fleabane	<i>Pluchea odorata</i>	20/50	3
Hedge nettle	<i>Stachys ajugoides</i>	N/A	2
		Total:	21
Cuttings (Valve Replacement Area)		Center (feet)	Quantity required
Mule fat	<i>Baccharis salicifolia</i>	5	10

This Revegetation Plan is in accordance with the East Shepherd Canyon Water Main Break Repair Project post-impact report. Revegetation will occur in the temporarily impacted areas outside of existing access paths and the previously disturbed area directly adjacent to the pipe repair area. Native seed will be applied by hand to the valve replacement and pipe replacement areas, as well as the previously disturbed area bordering the pipe repair area. No planting or seeding will occur in the back-hoe tire rut area. Mule fat cuttings will be installed only in the valve replacement area. Container plants will be 1 gallon and installed in the pipe repair area and the bordering disturbed area; however, large deep-rooted container plants (i.e., trees) will be installed no less than 10 feet from underground water and sewer lines. The revegetation areas will be monitored and maintained for 25 months.

Irrigation Note: All plant species selected are native species that will not require permanent irrigation. Supplemental irrigation will be implemented, if needed, via hand-watering to mimic natural rainfall and to aid in establishment of plantings.
